DAM INSPECTION CHECKLIST POSSUM POINT POWER STATION POND ABC

INSPECTION DATE: 4/6/15

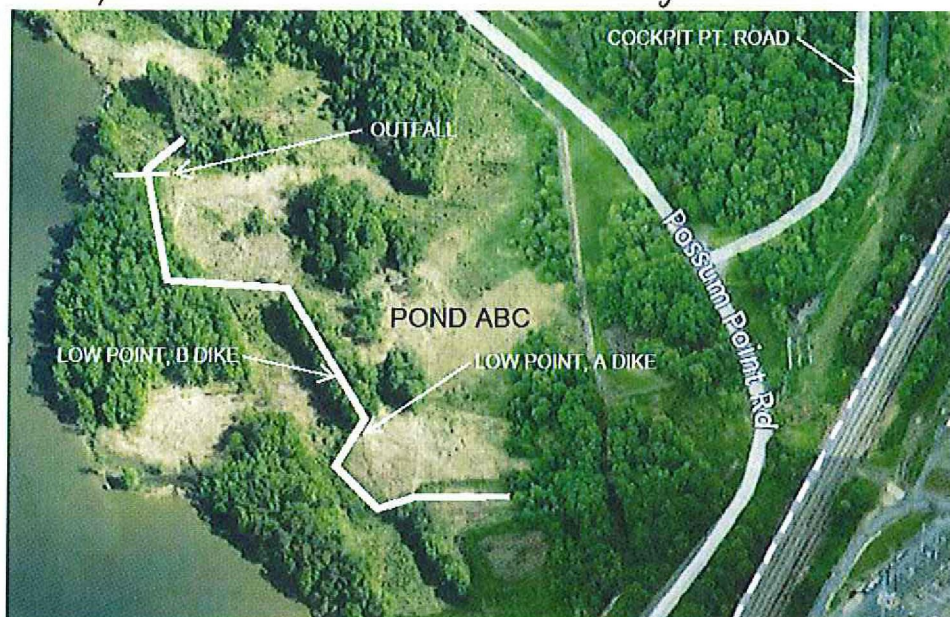
* See figure below.

Location/ Condition	(y/n)	Change (y/n)	Comments
Low Point, A dike*			
Flow	✓	✓	1407 hrs. Standing water along perimeter of pond
Erosion	✓	✓	by road. Small amount of standing water behind sandbags.
Low Point, B dike*			
Flow	✓	✓	1411 hrs. Sand bags and rip rap in place. Standing
Erosion	✓	✓	water at base of slope between A and B.
Outfall water surface El. (top of stoplogs to water)			1355 hrs. Standing water behind weir. water seeping into concrete weir structure. 50". Standing water behind sandbags. No standing water. DAW
